Group	1	Structure and operation	3-1
Group	2	Operation and maintenance	3-60
Group	3	Disassembly and assembly	3-73
Group	4	Adjustment	3-191

GROUP 1 STRUCTURE AND OPERATION

1. POWER TRAIN COMPONENT OVERVIEW

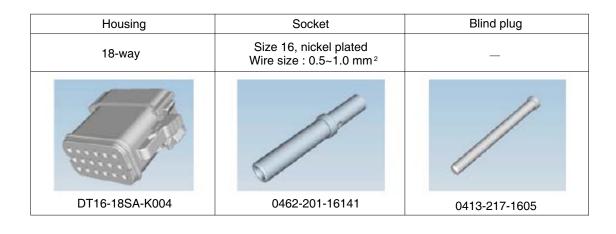
All connections terminate in the 18-way Deutsch integrated connector. Mating connector is DT16-18SA-K004.

Output connector			
Terminal	Designation		
1	-		
2	CAN_H		
3	CAN_H*		
4	CAN_T		
5	KL15		
6	-		
7	-		
8	CAN_L*		
9	CAN_L		
10	GND		
11	KL30		
12	-		
13	-		
14	-		
15	-		
16	-		
17	-		
18	-

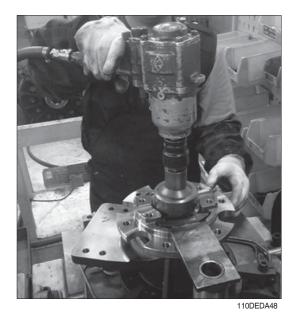
110DEDA49

- (10) Disassemble the pinion shaft (25) from the differential flange (29) by using tools.
- A Be careful imprints on the pinion shaft and oil seal damage.

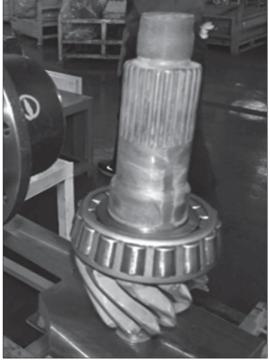
110DEDA54

Inner ring of bearings should be heated up to 100°C by a preheater.

Assemble the bevel pinion shaft and set the preload with the ring and the shim.

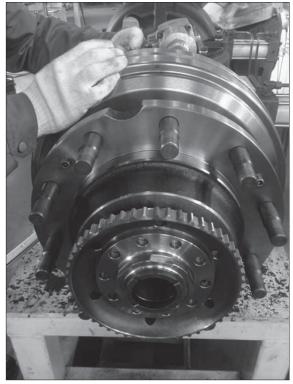
110DEDA82

- (8) Assemble the wheel hub assy into axle housing assy and tighten 24 bolts.
 Tightening torque : 20.5~51.54 kgf · cm
- Be careful not to damage the oil seal and align the center exactly when assembling the wheel hub assy to the axle housing

Do not reuse the damaged oil seal.

assy.

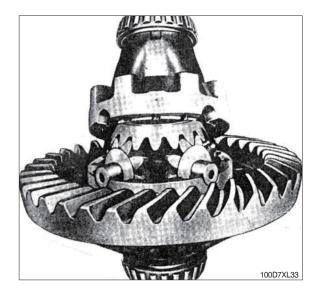
- (5) Check that all differential pinions can rotate easily.
- (6) Coat the contact surface of the ring gear with Loctite 270 and install the ring gear on the differential case by tapping lightly on the circumference. Tighten the ring gear bolts. Secure with Loctite 262.
- (7) Heat the two taper roller bearings to about 100°C and install them by using a sleeve.

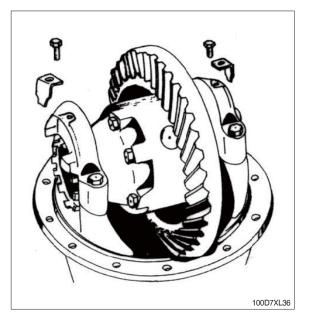
- (1) Place the differential with the outer rings of the taper roller bearings on the differential carrier which is in a vertical position, with mounted drive pinion.
