SECTION 3 POWER TRAIN SYSTEM

GROUP 1 STRUCTURE AND FUNCTION

1. POWER TRAIN COMPONENT OVERVIEW

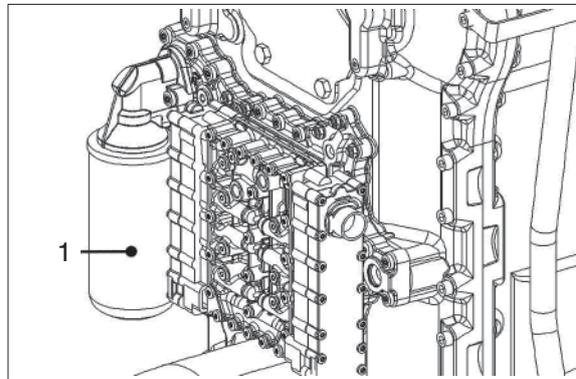
② Loosen Torx screws (2) and separate filter head (1) from transmission housing.

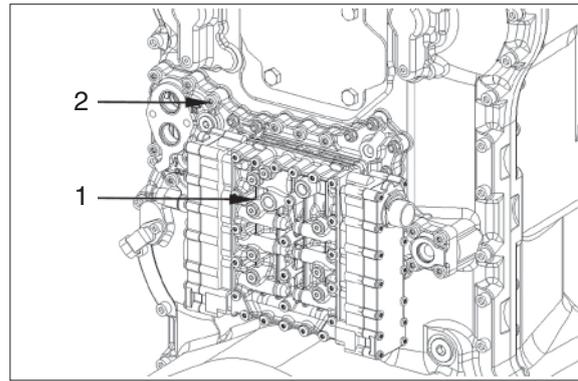
7609ATM004

- ② Remove gear-shift control assy (1) and sealing plate (2).

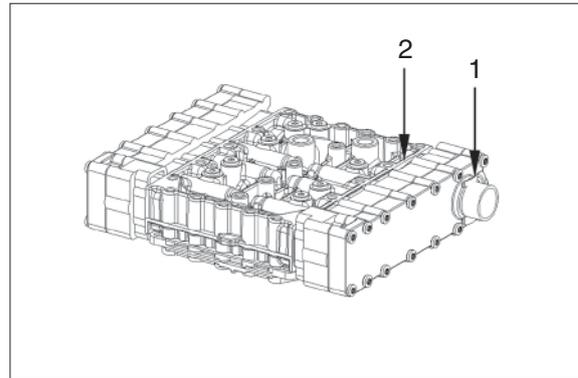
7609ATM009

- ⑦ Loosen Torx screws (1).

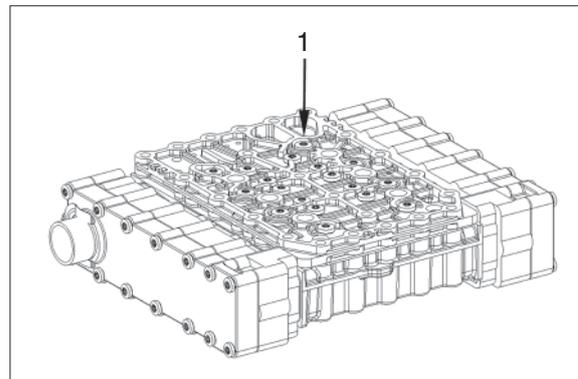
7609ATM010

- ⑧ Separate duct plate (1) and sealing plate (2) from valve block (3).

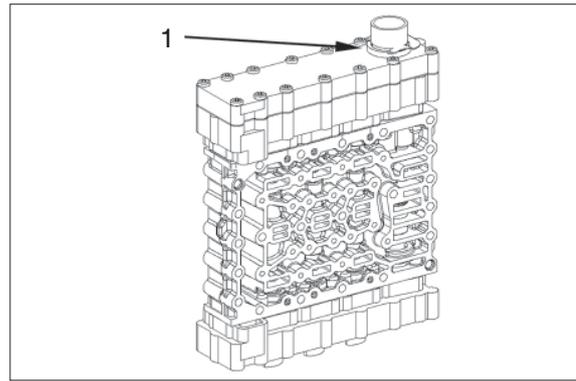
7609ATM012

- ⑩ Loosen Torx screws (1) and remove cover (2).
Remove opposite cover (3) in the same way.

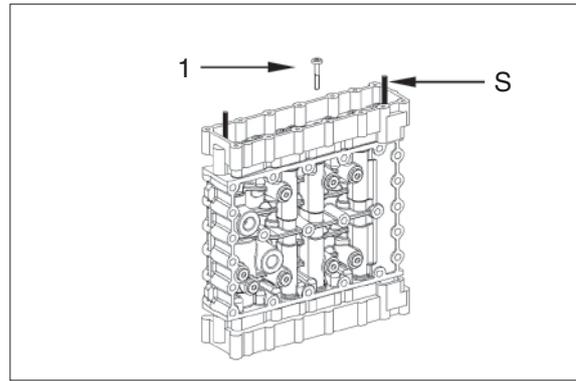
7609ATM016

- ⑭ Separate housing from valve housing by loosening the adjusting screws equally.

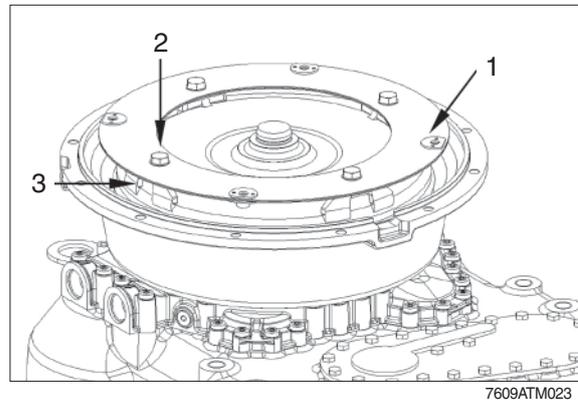
- ① Loosen hexagon screw (2) and separate flexplate (1) from converter (3).

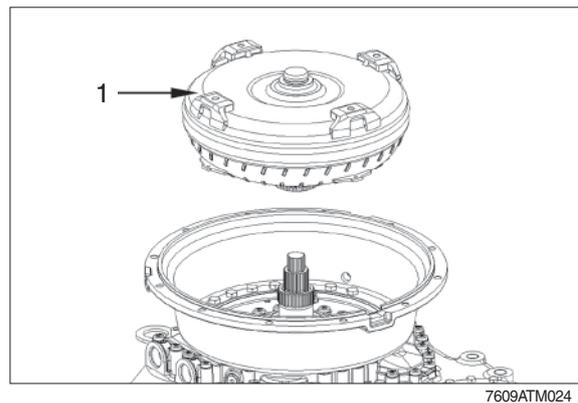
- ② Separate converter (1) from transmission by means of lifting device.

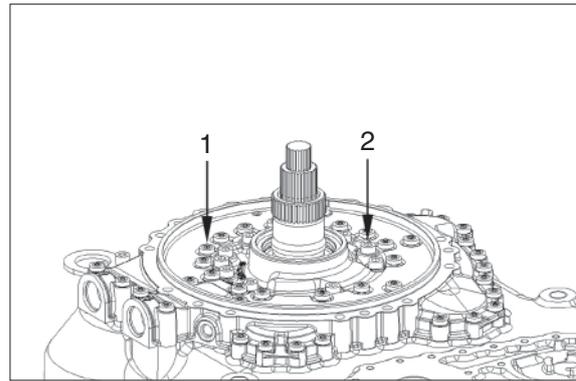
7609ATM026

- ③ Separate oil pressure pump (1) from oil feed housing (2).

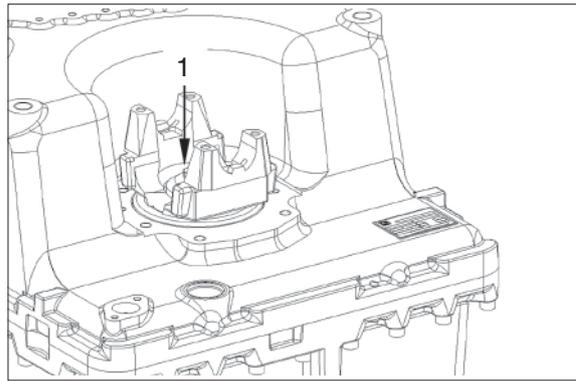
7609ATM036

- ② Pull off output flange (1) and remove shaft seal (2).

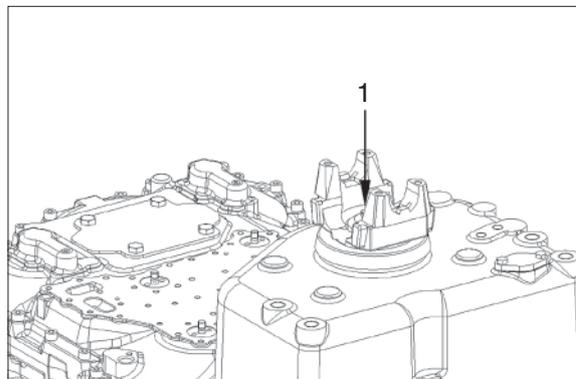
7609ATM038

- ② Pull off output flange (1) and remove shaft seal (2).

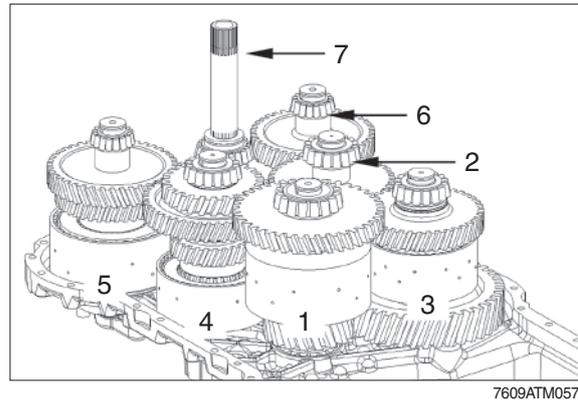
- 1 K1 clutch
- 2 K2 clutch
- 3 K3 clutch
- 4 K4 clutch
- 5 KR clutch
- 6 KV clutch
- 7 input shaft

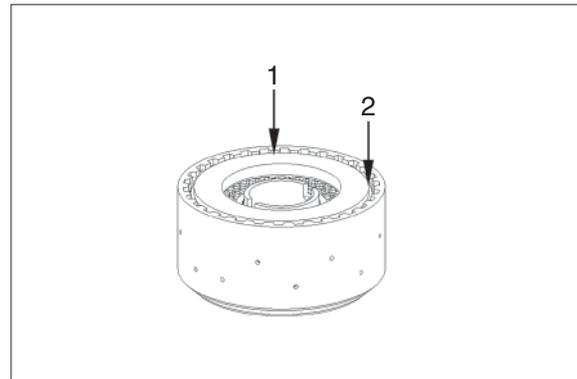
7609ATM164

- ⑭ Press on end plate with F (approx. 100 N = 10 kg) and set dial indicator to "zero".

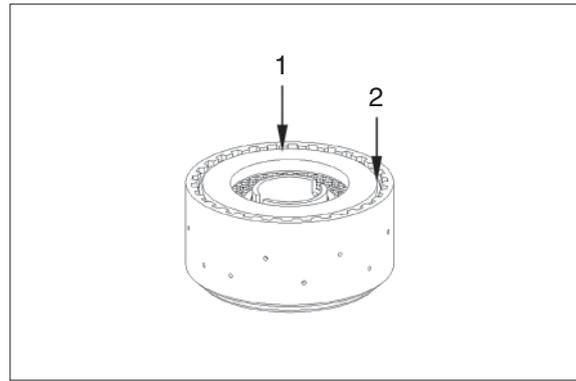
7609ATM188

- ⑭ Press on end plate with F (approx. 100 N = 10 kg) and set dial indicator to "zero".

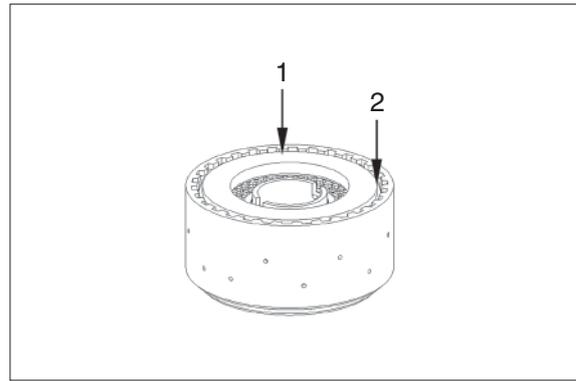
7609ATM208

- ⑩ Press on end plate with F (approx. 100 N = 10 kg) and set dial indicator to "zero".

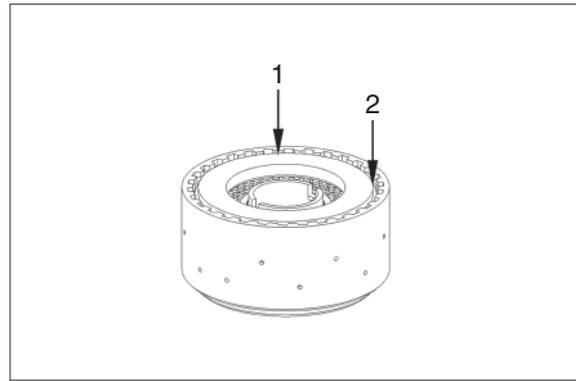
7609ATM255

- ⑪ Press on end plate with F (approx. 100 N = 10 kg) and set dial indicator to "zero".

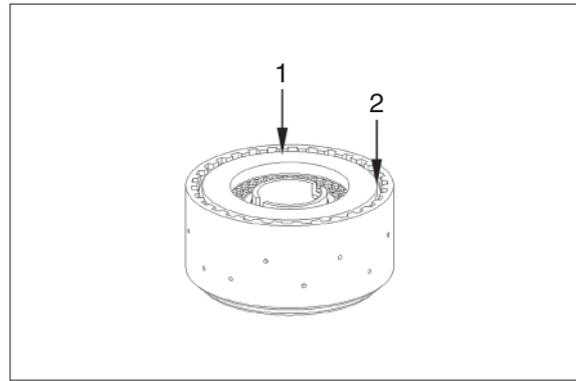
7609ATM283

- ⑯ Press on end plate with F (approx. 100 N = 10 kg) and set dial indicator to "zero".

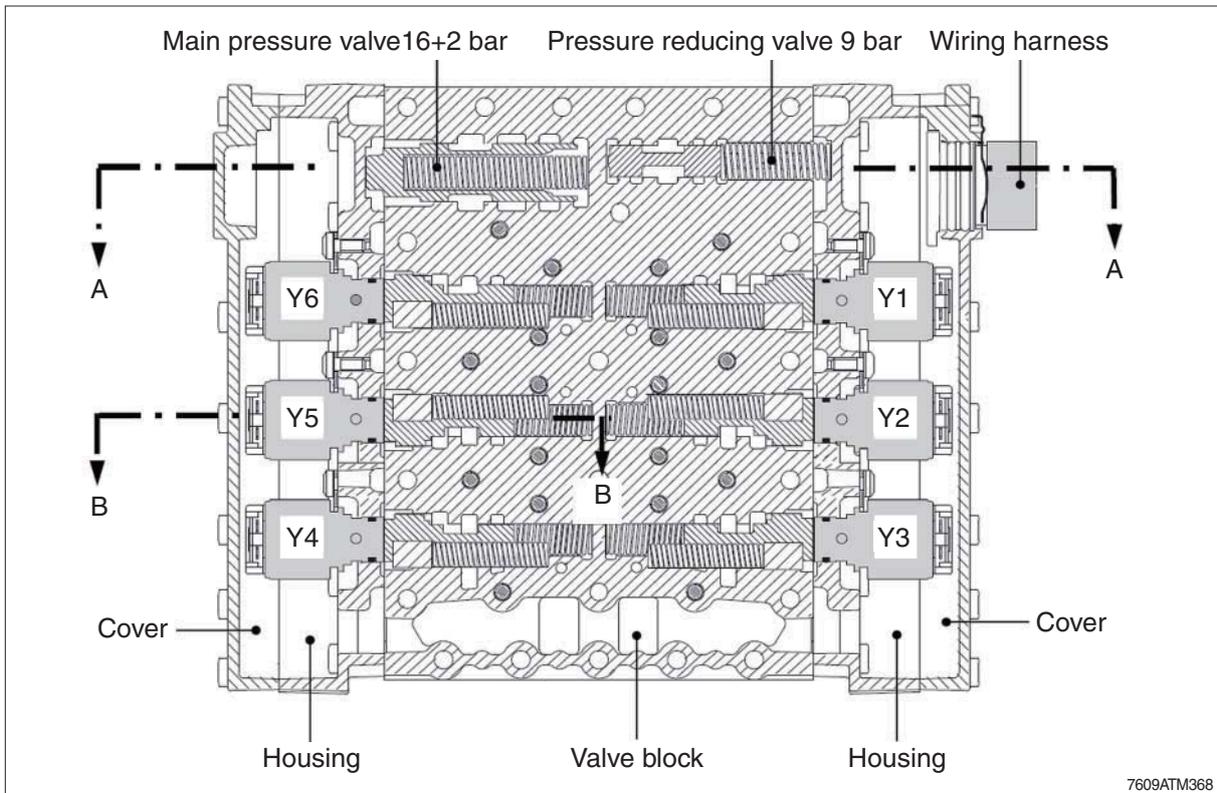
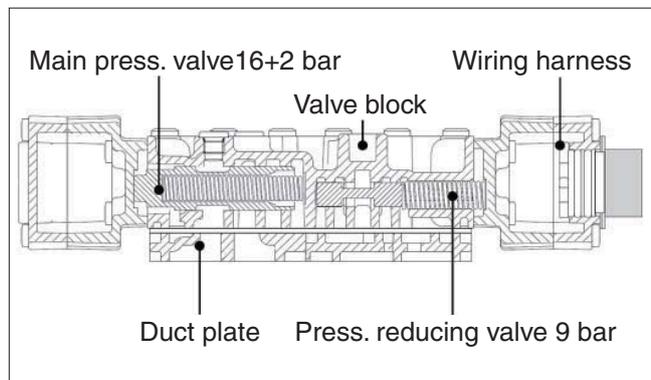
※ The following sketches show the sectional views of the electro-hydraulic control.

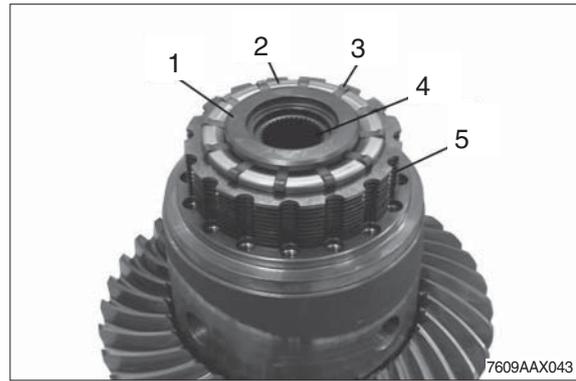
- 1 Pressure piece
- 2 Cage
- 3 Lever (12EA)
- 4 Disk carrier
- 5 Disk package
