SECTION 3 POWER TRAIN SYSTEM

GROUP 1 STRUCTURE AND FUNCTION

1. POWER TRAIN COMPONENT OVERVIEW

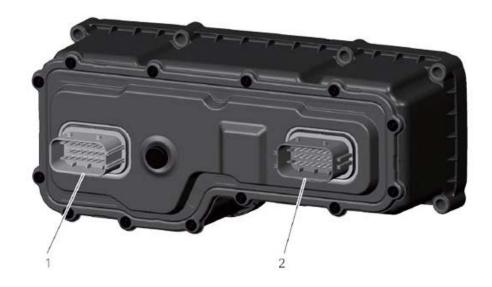
960T33PT13

- 1 Transmission connector
- 2 Machine connector

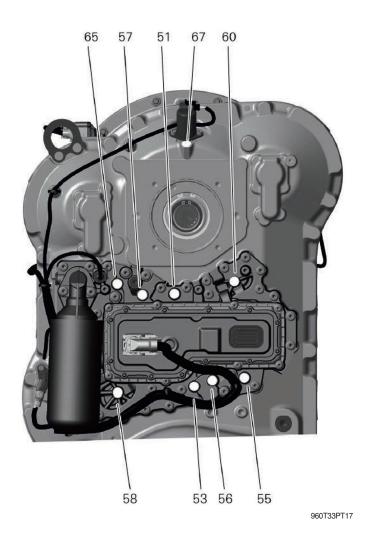
The measurements have to be carried out at hot transmission (about 80~95°C).

Measuring point	Measurement variable pressure/ temperature
51	11 + 2 bar
52 (not shown)	4.3 + 3 bar
53	16 + 3 bar
55	16 + 3 bar
56	16 + 3 bar
57	16 + 3 bar
58	16 + 3 bar
60	16 + 3 bar
65	16 + 3 bar
67	15 + 1 bar

- 51 Measuring point for pressure before converter, M12 x 1.5
- 53 Measuring point for clutch KV, M12 x 1.5
- 55 Measuring point for pressure oil of clutch KR, M12 x 1.5
- Measuring point for pressure oil of clutch K1, M12 x 1.5
- 57 Measuring point for pressure oil of clutch K2, M12 x 1.5
- 58 Measuring point for pressure oil of clutch K3, M12 x 1.5
- 60 Measuring point for pressure oil of clutch K4, M12 x 1.5
- 65 Measuring point for system pressure, M12 x 1.5
- 67 Measuring point for pressure in torque converter lock-upclutch, M12 x 1.5 (not used)
